**Flood Control Project Maintenance
Levee Inspections**

Fall 2016 Levee Maintenance Deficiency Summary Report

Sacramento River Basin

NA0001	Overall LMA Rating	Total LMA Miles						
American River Flood Control District	A	34.47						
Rated Item	Maintenance Deficiency				Enforcement		Design & System Obsolescence	
	M Miles	U Miles	M + 4U Miles	Threshold %	M Miles	U Miles	M Miles	U Miles
<i>Earthen Levee</i>								
Vegetation	0.05		0.05	0.15%	0.73	0.38		
Encroachments					1.07	3.34		
Animal Control	0.02		0.02	0.06%				
Slope Stability	0.08		0.08	0.23%				
<i>Supplemental</i>								
2015 USACE Erosion Survey, DRAFT	0.04		0.04	0.12%				
DWR UCIP Field Study					0.96	0.07		
<i>LMA Totals:</i>	0.19	0.00	0.19	0.55%	2.76	3.79	0.00	0.00
Unit No. 01 Arcade Creek LB	Overall Unit Rating	Total Unit Miles						
NA0001	A	2.08						
Rated Item	Maintenance Deficiency				Enforcement		Design & System Obsolescence	
	M Miles	U Miles	M + 4U Miles	Threshold %	M Miles	U Miles	M Miles	U Miles
<i>Earthen Levee</i>								
Vegetation	0.01		0.01	0.48%	0.04	0.03		
Encroachments					0.30	0.27

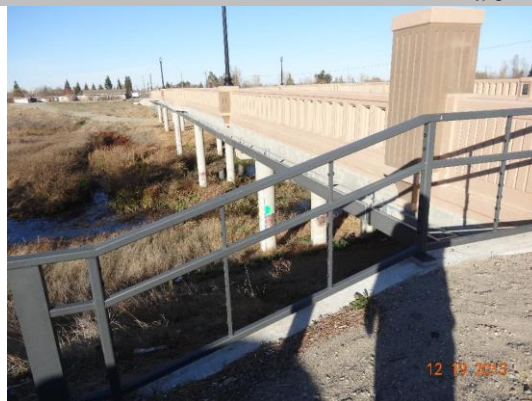
Photo 1 of 2 : UCIP_FA_2016_49930_57042.jpg

LM Start	0.66	Rating **	U	Issue No.	193 (cont)
LM End	0.66	Issue Type +	En	Location *	LS

View of WS--pipe suspended along downstream face of bridge.

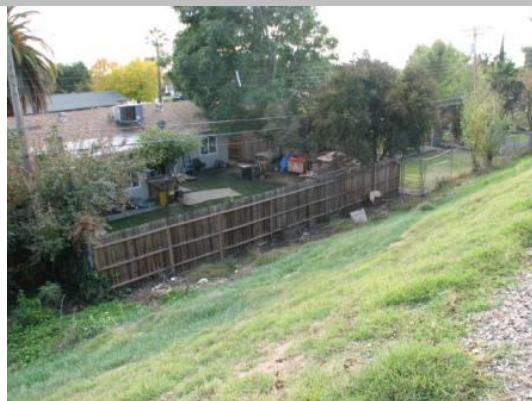
Photo 1 of 1 : FA_2016_NA0001_51_183_20160914_00063.jpg

LM Start	0.77	Rating **	U	Issue No.	183
LM End	0.77	Issue Type +	En	Location *	LS
Category	Earthen Levee			GPS Latitude/Longitude	
				Start	End
Item	Encroachments			38.624016 °	38.624016 °
				-121.455193 °	-121.455193 °
DWR ID	DWR_NA0001_01_s_2012_183				
Comment Code					
FE : Fence					
Inspector Comment					
Dog-eared fence built within 10' of the toe

11/17/2011 Wooden privacy fence.

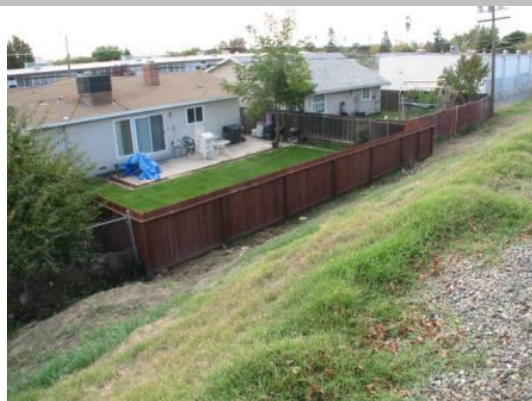
Photo 1 of 1 : FA_2016_NA0001_51_182_20160914_00062.jpg

LM Start	0.95	Rating **	U	Issue No.	182
LM End	0.95	Issue Type +	En	Location *	LS
Category	Earthen Levee			GPS Latitude/Longitude	
				Start	End
Item	Encroachments			38.625072 °	38.625072 °
				-121.452225 °	-121.452225 °
DWR ID	DWR_NA0001_01_s_2012_182				
Comment Code					
FE : Fence					
Inspector Comment					
Dog-eared wooden fence built within 10' of the toe.

11/17/2011 Wooden privacy fence built at the levee toe.

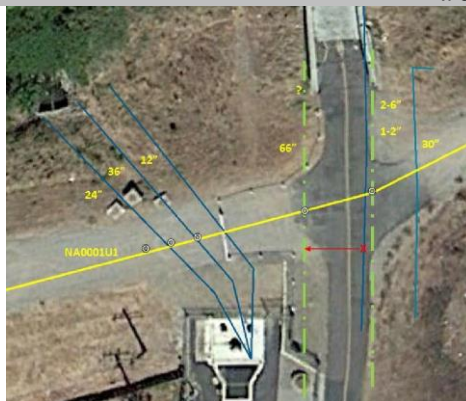
Photo 1 of 1 : UCIP_FA_2016_31178_57059.jpg

LM Start	1.22	Rating **	M	Issue No.	187
LM End	1.22	Issue Type +	En	Location *	LS
Category	Supplemental			GPS Latitude/Longitude	
				Start	End
Item	DWR UCIP Field Study			38.625117 °	38.625117 °
				-121.447318 °	-121.447318 °
DWR ID					
Comment Code					
Inspector Comment					
FS_ID:31178 DS_ID:24248 EP_NO: 14575 Repair Type: Non-Urgent Crossing Status: Not Found UCIP Comments: Crossing is present in the layer provided by the City of Sacramento, however this crossing was not found in the field. Need to determine status of crossing. If crossing is no longer used, owner will need to coordinate with Central Valley Flood Protection Board to comply with Title 23. FIELD_STRUCT_DESC: 30-inch concrete encased steel water main through the levee, 4.5 feet below the crown. Steel cutoff wall around pipe at center of levee. (Permit No. 14575-1988) FS Date: 12/19/2013

Alignment indicated in blue is approximate locations for pipes that cross levee. Alignment information was obtained from the City of Sacramento.

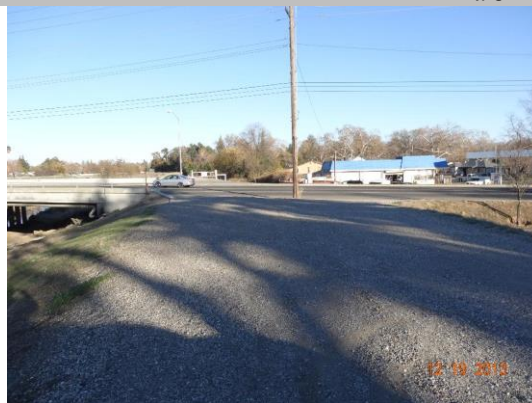
Photo 1 of 2 : UCIP_FA_2016_30085_55489.jpg

LM Start	1.28	Rating **	M	Issue No.	184
LM End	1.28	Issue Type +	En	Location *	LS
Category	Supplemental			GPS Latitude/Longitude	
				Start	End
Item	DWR UCIP Field Study			38.625500 °	38.625500 °
				-121.446390 °	-121.446390 °
DWR ID					
Comment Code					
Inspector Comment					
FS_ID:30085 DS_ID:24576 EP_NO: N/A Repair Type: Non-Urgent Crossing Status: Indicator Found UCIP Comments: Unable to confirm location--will need to coordinate with owner to determine if crossing is still active and determine location. FIELD_STRUCT_DESC: 1 of 3: 16-inch pipe through the levee, 8.0 feet below the crown. Floodgates within the levee across the channel, installed under Permit No. 14480 (1986). FS Date: 12/19/2013

Overview of levee crown at crossing.

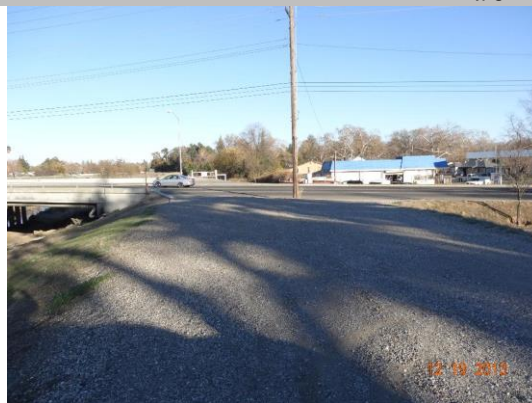
Photo 1 of 2 : UCIP_FA_2016_29732_54976.jpg

LM Start	1.28	Rating **	M	Issue No.	185
LM End	1.28	Issue Type +	En	Location *	LS
Category	Supplemental			GPS Latitude/Longitude	
				Start	End
Item	DWR UCIP Field Study			38.625500 °	38.625500 °
				-121.446390 °	-121.446390 °
DWR ID					
Comment Code					
Inspector Comment					
FS_ID:29732					
DS_ID:24577					
EP_NO: N/A					
Repair Type: Non-Urgent					
Crossing Status: Indicator Found					
UCIP Comments: Unable to confirm location--will need to coordinate with owner to determine if crossing is still active and determine location.					
FIELD_STRUCT_DESC: 2 of 3: 6-inch pipe through the levee, 8.0 feet below the crown. Flap gate on the waterside (WS) end. Floodgates within the levee across the channel, installed under Permit No. 14480 (1986).					
FS Date: 12/19/2013

Overview of levee crown.

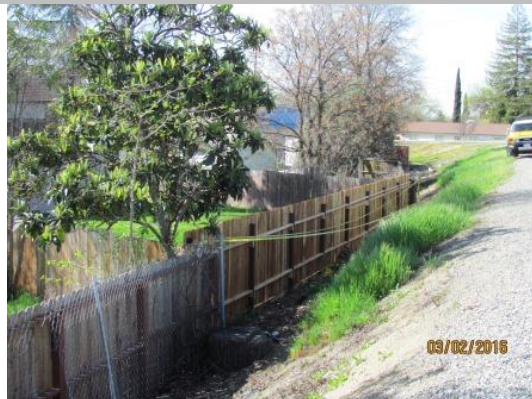
Photo 1 of 1 : FA_2016_NA0001_51_73_20160914_00045.jpg

LM Start	1.33	Rating **	U	Issue No.	73
LM End	1.33	Issue Type +	En	Location *	LS
Category	Earthen Levee			GPS Latitude/Longitude	
				Start	End
Item	Encroachments			38.625869 °	38.625869 °
				-121.445477 °	-121.445477 °
DWR ID	DWR_NA0001_01_f_2015_73				
Comment Code					
FE : Fence					
Inspector Comment					
Fence at LS toe.

View of the fence at the landside levee toe.

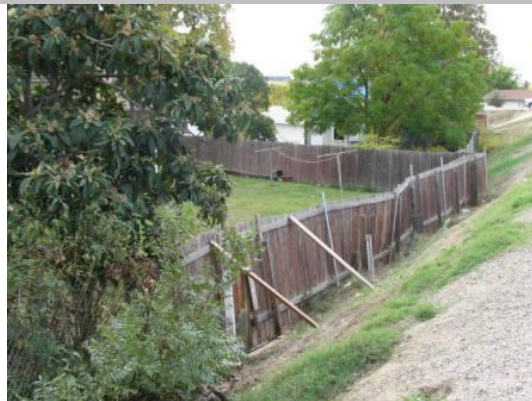
Photo 1 of 1 : FA_2016_NA0001_51_17_20160914_00015.jpg

LM Start	1.33	Rating **	U	Issue No.	17
LM End	1.33	Issue Type +	En	Location *	LS
Category	Earthen Levee			GPS Latitude/Longitude	
				Start	End
Item	Encroachments			38.625885 °	38.625885 °
				-121.445424 °	-121.445424 °
DWR ID	DWR_NA0001_01_s_2012_17				
Comment Code					
FE : Fence					
Inspector Comment					
Wooden privacy fence

11/17/2011 Wooden privacy fence built at the levee toe. Levee slope is being used to support the fence.

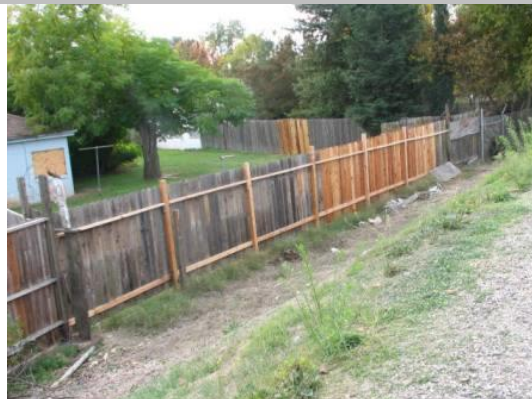
Photo 1 of 1 : FA_2016_NA0001_51_13_20160914_00011.jpg

LM Start	1.40	Rating **	U	Issue No.	13
LM End	1.40	Issue Type +	En	Location *	LS
Category	Earthen Levee			GPS Latitude/Longitude	
				Start	End
Item	Encroachments			38.626155 °	38.626155 °
				-121.444250 °	-121.444250 °
DWR ID	DWR_NA0001_01_s_2012_13				
Comment Code					
FE : Fence					
Inspector Comment					
Wooden fence with barbed wire is built within 10-ft of levee toe. 04/13/2011 Fence has blown over and now partially rests on the levee. Fall insp 2011 fence has been rebuilt in same location, within 10' of levee toe.

11/17/2011 New wooden privacy fence built within 15' of the levee toe.

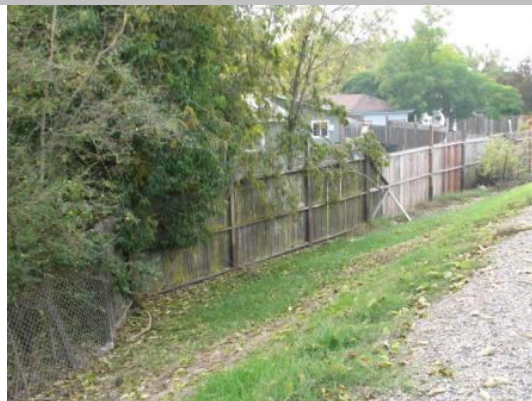
Photo 1 of 1 : FA_2016_NA0001_51_12_20160914_00010.jpg

LM Start	1.41	Rating **	U	Issue No.	12
LM End	1.41	Issue Type +	En	Location *	LS
Category	Earthen Levee			GPS Latitude/Longitude	
				Start	End
Item	Encroachments			38.626212 °	38.626212 °
				-121.444082 °	-121.444082 °
DWR ID	DWR_NA0001_01_s_2012_12				
Comment Code					
FE : Fence					
Inspector Comment					
Dog-eared wooden fence is built near the levee slope.

11/17/2011 Wooden privacy fence built within 15' of the levee toe.

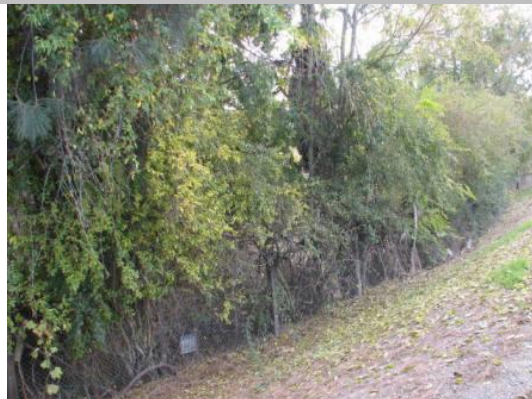
Photo 1 of 1 : FA_2016_NA0001_51_177_20160914_00060.jpg

LM Start	1.42	Rating **	U	Issue No.	177
LM End	1.42	Issue Type +	En	Location *	LS
Category	Earthen Levee			GPS Latitude/Longitude	
				Start	End
Item	Vegetation			38.626388 °	38.626388 °
				-121.443910 °	-121.443910 °
DWR ID	DWR_NA0001_01_s_2012_177				
Comment Code					
V6 : Landscaping					
Inspector Comment					
Thick vegetation at the toe.

11/17/2011 Thick vegetation at the levee toe.

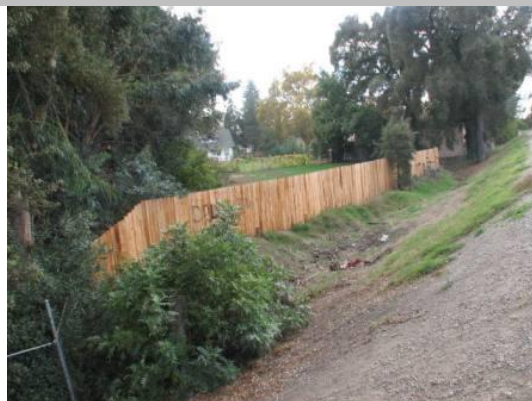
Photo 1 of 1 : FA_2016_NA0001_51_176_20160914_00059.jpg

LM Start	1.47	Rating **	A/W	Issue No.	176
LM End	1.47	Issue Type +	En	Location *	LS
Category	Earthen Levee			GPS Latitude/Longitude	
				Start	End
Item	Encroachments			38.626881 °	38.626881 °
				-121.443253 °	-121.443253 °
DWR ID	DWR_NA0001_01_s_2012_176				
Comment Code					
FE : Fence					
Inspector Comment					
Wooden privacy fence within 10' of the levee toe.

11/17/2011 Wooden privacy fence built within 15' of the levee toe.

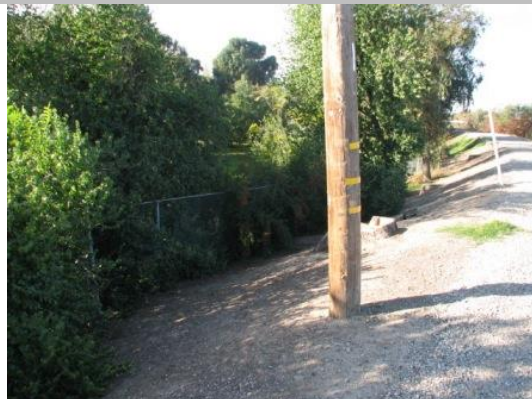
Photo 1 of 1 : FA_2016_NA0001_51_35_20160914_00027.jpg

LM Start	1.53	Rating **	M	Issue No.	35
LM End	1.53	Issue Type +	En	Location *	LS
Category	Earthen Levee			GPS Latitude/Longitude	
				Start	End
Item	Vegetation			38.627255 °	38.627255 °
				-121.442402 °	-121.442402 °
DWR ID	DWR_NA0001_01_s_2012_35				
Comment Code					
V6 : Landscaping					
Inspector Comment					
Bushes and trees along chain link fence block access and visibility.

Fall 2009 photo:Vegetation obstructing visibility near levee slope.

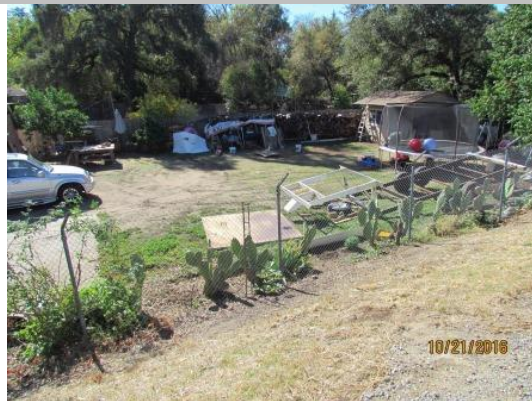
Photo 1 of 1 : FA_2016_NA0001_51_68_20161031_00093.jpg

LM Start	1.54	Rating **	M	Issue No.	68
LM End	1.54	Issue Type +	En	Location *	LS
Category	Earthen Levee			GPS Latitude/Longitude	
				Start	End
Item	Vegetation			38.627283 °	38.627283 °
				-121.442180 °	-121.442180 °
DWR ID	DWR_NA0001_01_f_2015_68				
Comment Code					
V6 : Landscaping					
Inspector Comment					
Cactus planted along LS toe.

View of the landscaping at the landside levee toe.

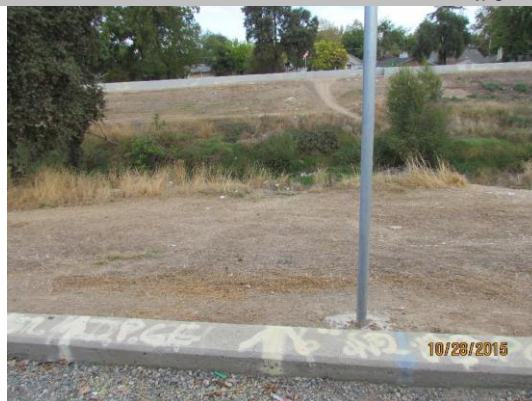
Photo 1 of 2 : UCIP_FA_2016_46793_74731.jpg

LM Start	1.57	Rating **	M	Issue No.	192
LM End	1.57	Issue Type +	En	Location *	LS
Category	Supplemental			GPS Latitude/Longitude	
				Start	End
Item	DWR UCIP Field Study			38.627277 °	38.627277 °
				-121.441650 °	-121.441650 °
DWR ID					
Comment Code					
Inspector Comment					
FS_ID:46793 DS_ID:24573 EP_NO: N/A Repair Type: Non-Urgent Crossing Status: Indicator Found UCIP Comments: 11/12/15 Markers have been installed on both levees--confirmed during DWR Fall Inspection. Need to coordinate with PG&E to determine permit for this crossing.12/19/13 No markers visible indicating crossing through levee. PG&E line. Need to coordinate with owner. Permit? FIELD_STRUCT_DESC: 2 of 2: 6-inch pipe through the levee, at unknown depth and goes under the channel. FS Date: 11/12/2015 1:52:00 PM

Markers installed on both levees in 2015.

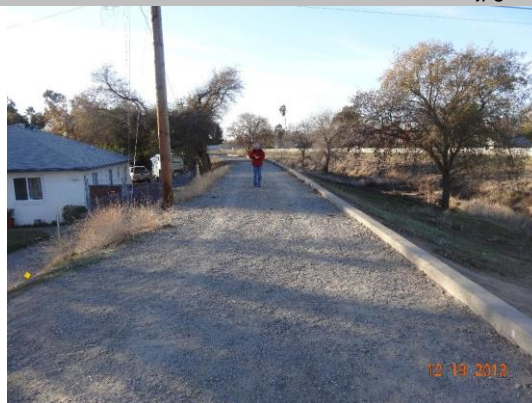
Photo 2 of 2 : UCIP_FA_2016_46793_57072.jpg

Overview of area near crossing. Inspector is standing where crossing goes through levee.

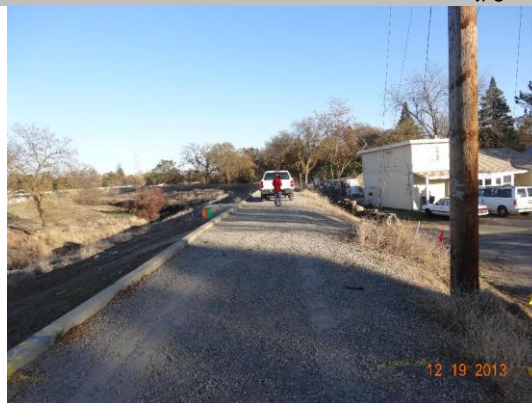
Photo 2 of 2 : UCIP_FA_2016_31182_57076.jpg

Overview of levee at crossing.

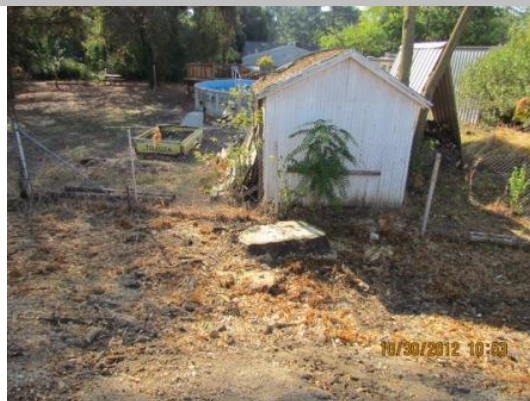
Photo 1 of 1 : FA_2016_NA0001_51_31_20160914_00025.jpg

LM Start	1.61	Rating **	N	Issue No.	31
LM End	1.61	Issue Type +	Ma	Location *	LS
Category	Earthen Levee			GPS Latitude/Longitude	
				Start	End
Item	Trim / Thin Trees			38.627191 °	38.627191 °
				-121.440861 °	-121.440861 °
DWR ID	DWR_NA0001_01_f_2012_31				
Comment Code					
T5 : Tree stumps.					
Inspector Comment

View of large tree stump at levee toe.

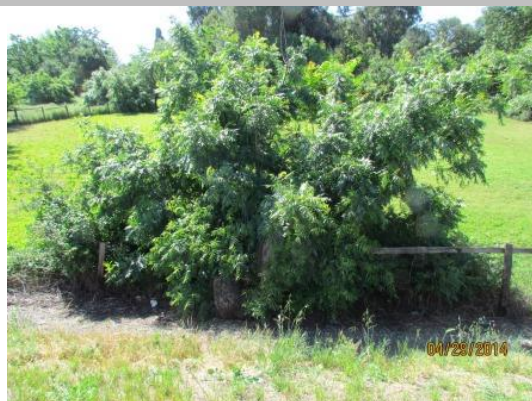
Photo 1 of 1 : FA_2016_NA0001_51_48_20160914_00031.jpg

LM Start	1.69	Rating **	M	Issue No.	48
LM End	1.69	Issue Type +	Ma	Location *	LS
Category	Earthen Levee			GPS Latitude/Longitude	
				Start	End
Item	Vegetation			38.627594 °	38.627594 °
				-121.439540 °	-121.439540 °
DWR ID	DWR_NA0001_01_s_2014_48				
Comment Code					
V2 : Remove the wild growth other than native grasses from the levee slopes.					
Inspector Comment					
Tree obstructing visibility and access.

View of the overgrown tree at the landside levee toe.

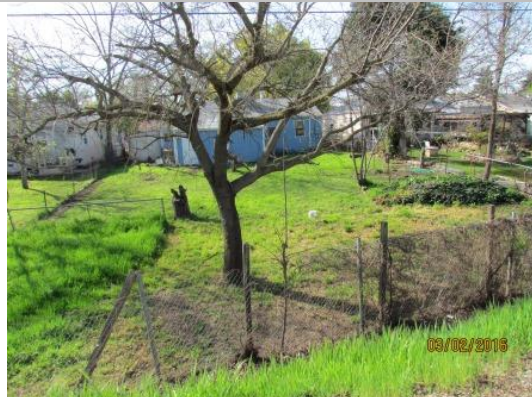
Photo 1 of 1 : FA_2016_NA0001_51_61_20160914_00040.jpg

LM Start	1.86	Rating **	M	Issue No.	61
LM End	1.86	Issue Type +	En	Location *	LS
Category	Earthen Levee			GPS Latitude/Longitude	
				Start	End
Item	Encroachments			38.627885 °	38.627885 °
				-121.436423 °	-121.436423 °
DWR ID	DWR_NA0001_01_f_2015_61				
Comment Code					
FE : Fence					
Inspector Comment					
Fence at landside levee toe.

View of the fence at the landside levee toe.

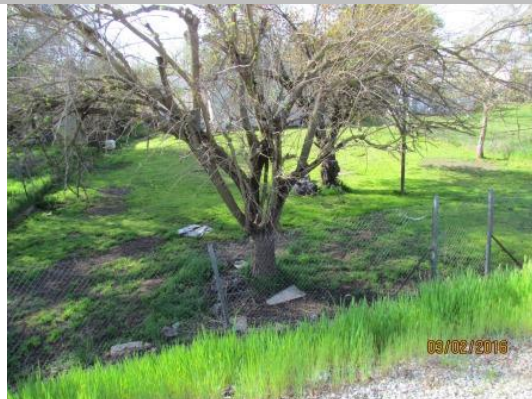
Photo 1 of 1 : FA_2016_NA0001_51_59_20160914_00038.jpg

LM Start	1.88	Rating **	M	Issue No.	59
LM End	1.88	Issue Type +	En	Location *	LS
Category	Earthen Levee			GPS Latitude/Longitude	
				Start	End
Item	Encroachments			38.627871 °	38.627871 °
				-121.436191 °	-121.436191 °
DWR ID	DWR_NA0001_01_f_2015_59				
Comment Code					
FE : Fence					
Inspector Comment					
Fence at landside levee toe.

View of the fence at the landside levee toe.

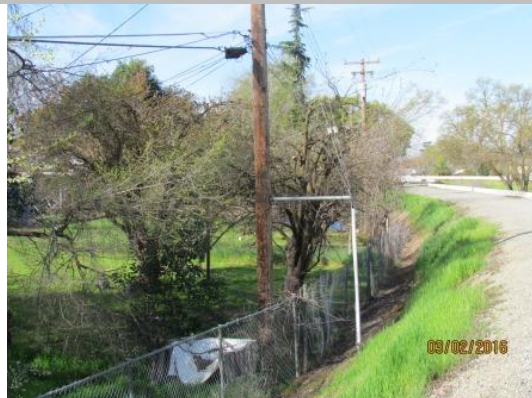
Photo 1 of 1 : FA_2016_NA0001_51_58_20160914_00037.jpg

LM Start	1.88	Rating **	M	Issue No.	58
LM End	1.88	Issue Type +	En	Location *	LS
Category	Earthen Levee			GPS Latitude/Longitude	
				Start	End
Item	Encroachments			38.627860 °	38.627860 °
				-121.436098 °	-121.436098 °
DWR ID	DWR_NA0001_01_f_2015_58				
Comment Code					
PO : Pole					
Inspector Comment					
Pole at the landside levee toe with guy wire penetrating the landside levee slope.

View of the pole at the landside levee toe.

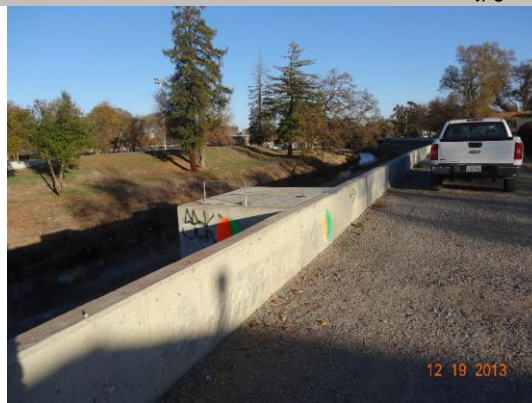
Photo 2 of 2 : UCIP_FA_2016_41549_57086.jpg

View of floodwall along waterward side.

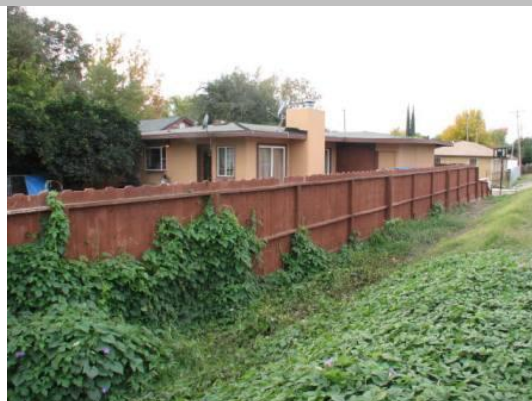
Photo 1 of 1 : FA_2016_NA0001_51_167_20160914_00053.jpg

LM Start	1.98	Rating **	U	Issue No.	167
LM End	1.98	Issue Type +	En	Location *	LS
Category	Earthen Levee			GPS Latitude/Longitude	
				Start	End
Item	Encroachments			38.627433 °	38.627433 °
				-121.434341 °	-121.434341 °
DWR ID	DWR_NA0001_01_s_2012_167				
Comment Code					
FE : Fence					
Inspector Comment					
Wooden privacy fence within 10' of the levee toe.

11/17/2011 Wooden privacy fence built at the levee toe.

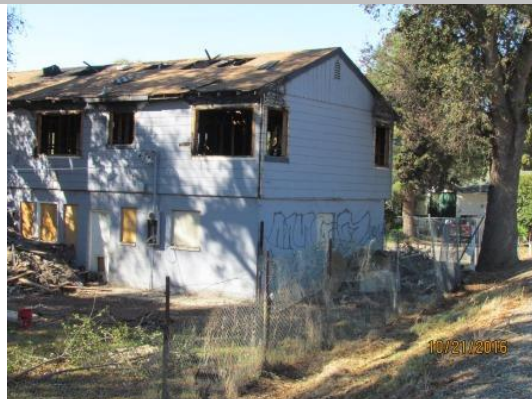
Photo 1 of 1 : FA_2016_NA0001_51_29_20161031_00092.jpg

LM Start	2.02	Rating **	U	Issue No.	29
LM End	2.02	Issue Type +	En	Location *	LS
Category	Earthen Levee			GPS Latitude/Longitude	
				Start	End
Item	Encroachments			38.627292 °	38.627292 °
				-121.433709 °	-121.433709 °
DWR ID	DWR_NA0001_01_s_2012_29				
Comment Code					
BU : Building					
Inspector Comment					
Two-story home foundation is within 10-ft of levee toe. Chain link fence is built on levee toe.

Building foundation is within 15' of the levee toe.

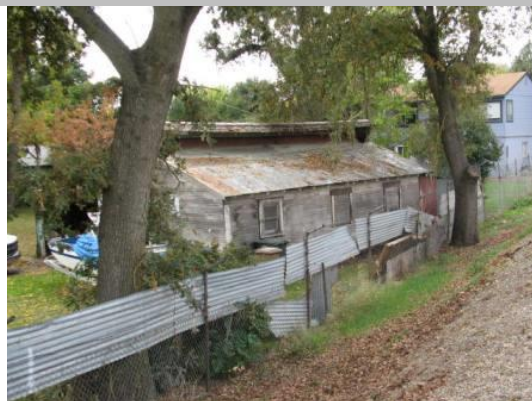
Photo 1 of 1 : FA_2016_NA0001_51_28_20160914_00022.jpg

LM Start	2.04	Rating **	U	Issue No.	28
LM End	2.04	Issue Type +	En	Location *	LS
Category	Earthen Levee			GPS Latitude/Longitude	
				Start	End
Item	Encroachments			38.627257 °	38.627257 °
				-121.433327 °	-121.433327 °
DWR ID	DWR_NA0001_01_s_2012_28				
Comment Code					
BU : Building					
Inspector Comment					
Large wooden building behind corrugated metal covered fence is within 10-ft of levee toe.

11/17/2011 Wooden structure is within 15' of the levee toe.

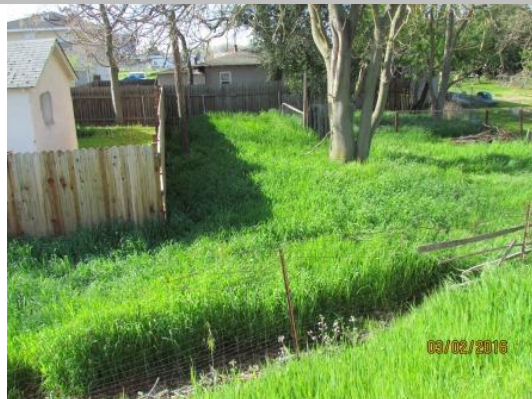
Photo 1 of 1 : FA_2016_NA0001_51_51_20160914_00033.jpg

LM Start	2.06	Rating **	M	Issue No.	51
LM End	2.06	Issue Type +	En	Location *	LS
Category	Earthen Levee			GPS Latitude/Longitude	
				Start	End
Item	Encroachments			38.627251 °	38.627251 °
				-121.432843 °	-121.432843 °
DWR ID	DWR_NA0001_01_f_2015_51				
Comment Code					
FE : Fence					
Inspector Comment					
Fence at landside levee toe.

View of the fence at the landside levee toe.

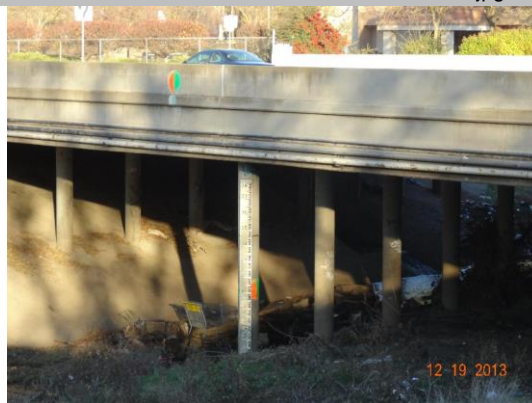
Photo 2 of 2 : UCIP_FA_2016_31185_57090.jpg

Markers visible of crossing on bridge.

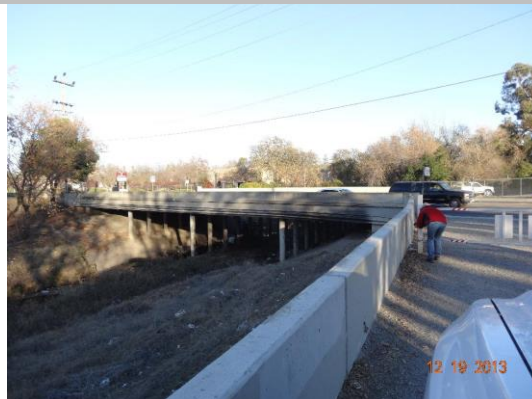
Photo 1 of 2 : UCIP_FA_2016_31424_57481.jpg

FS_ID:31424
DS_ID:24797
EP_NO: N/A
Repair Type: Non-Urgent
Crossing Status: Found
UCIP Comments: no permit--need to determine additional information and owner of crossings.
FIELD_STRUCT_DESC: 1-4 inch conduit and 1-2 inch communication cable through levee. Conduits are suspended through waterway and attached to downstream face of bridge.
FS Date: 12/19/2013

View of waterward side--conduits visible on bridge face.

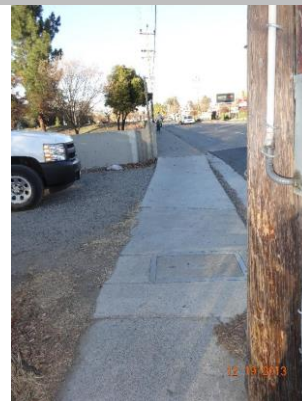
Photo 2 of 2 : UCIP_FA_2016_31424_57480.jpg

Service box located on sidewalk unable to determine if box belongs to conduits.

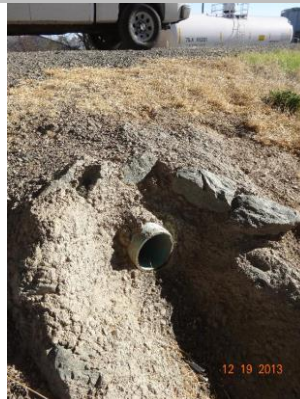
Photo 2 of 2 : UCIP_FA_2016_31443_57483.jpg

View of pipe through levee.

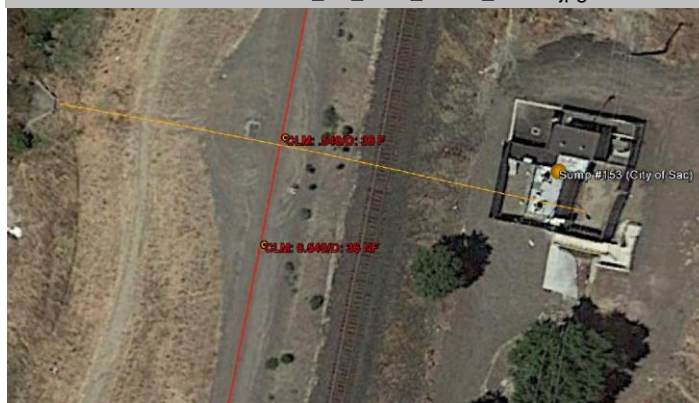
Photo 1 of 2 : UCIP_FA_2016_49532_75580.jpg

UCIP Comments: 08/29/2016 Facility details confirmed by the City of Sacramento. This crossing was an existing pipe that was mentioned in Permit No. 6064 and 6064-A under the following conditions: Thirteen:

Approx. location of USACE O&M original 36-inch located 40 feet downstream from Sump 153.

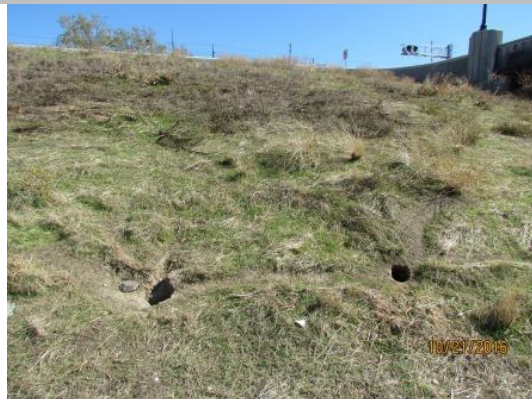
Photo 1 of 1 : FA_2016_NA0001_52_24_20161031_00048.jpg

LM Start	0.73	Rating **	M	Issue No.	24
LM End	0.73	Issue Type +	Ma	Location *	WS
Category	Earthen Levee			GPS Latitude/Longitude	
				Start	End
Item	Animal Control			38.611529 °	38.611529 °
				-121.466801 °	-121.466801 °
DWR ID	DWR_NA0001_02_s_2016_24				
Comment Code					
A1 : Exterminate rodents and backfill and compact or grout burrows.					
Inspector Comment					
Rodents still active in this area.

View of the rodent holes in the waterside levee slope.

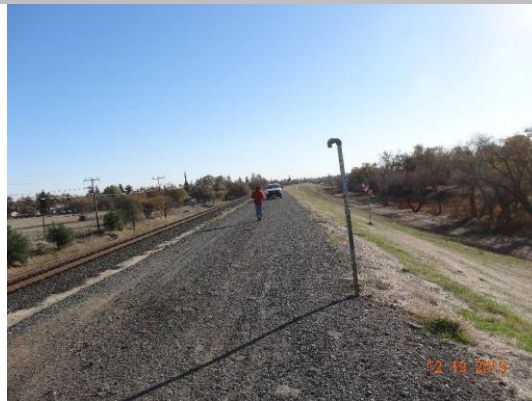
Photo 1 of 2 : UCIP_FA_2016_42132_55451.jpg

Comment Code					
Inspector Comment					
FS_ID:42132 DS_ID:24613 EP_NO: 2347 Repair Type: Non-Urgent Crossing Status: Indicator Found UCIP Comments: 11/3/2014 (DWR-Olivia) Need to contact owner to determine status of crossing. Priority under Part IX has been changed from Urgent to Non-Urgent as a measure to normalize the data. Markers present however unable to confirm pipe size. Recommend LMA to contact owner to determine additional information details--confirm pipe size, alignment, and last inspection completed confirming integrity of crossing.Need to contact owner to determine status of crossing. Unable to confirm if indicators visible on levee crown and landward side correspond to this crossing. FIELD_STRUCT_DESC: 6-inch gas line through the levee, 2.5 feet below the crown. For emergencies contact PG&E at 1-800-811-411. (Permit No. 2347-1957) FS Date: 12/19/2013

Overview of levee crown with utility gas markers on waterward side.

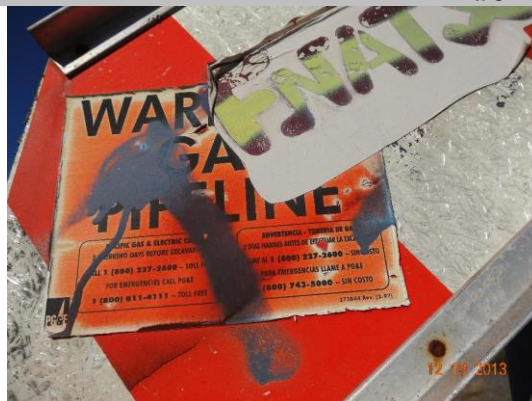
Photo 2 of 2 : UCIP_FA_2016_42132_55453.jpg

Contact information for owner--sign visible on waterward side slope.

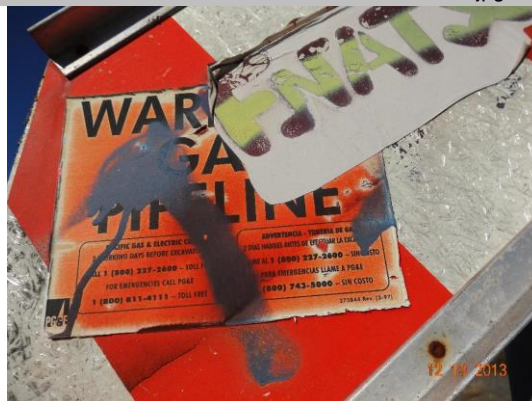
Photo 2 of 2 : UCIP_FA_2016_42130_52768.jpg

Marker with emergency contact information located on waterward slope.

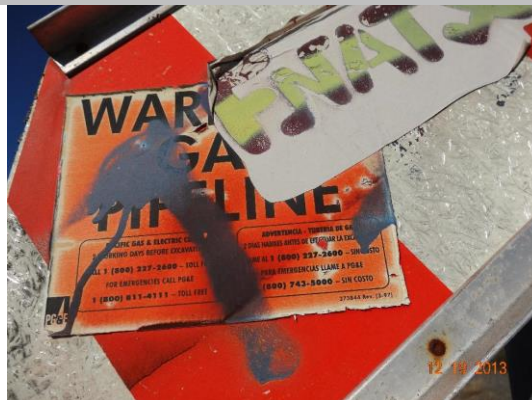
Photo 2 of 2 : UCIP_FA_2016_28666_52780.jpg

LM Start	1.03	Rating **	M	Issue No.	151
LM End	1.03	Issue Type +	En	Location *	WS
Category	Supplemental			GPS Latitude/Longitude	
				Start	End
Item	DWR UCIP Field Study			38.615772 °	38.615772 °
				-121.466971 °	-121.466971 °
DWR ID					
Comment Code					
Inspector Comment					
FS_ID:28666 DS_ID:24614 EP_NO: 1949 Repair Type: Non-Urgent Crossing Status: Indicator Found UCIP Comments: Need to contact owner to determine if pipe was left inside levee as part of abandonment process. FIELD_STRUCT_DESC: *Abandoned* 12-inch steel gas line through the levee, 3.0 feet below the crown. Pipe grout filled. Concrete cutoff wall around pipe under center of levee. (Permit No. 1450-1949) This entry matches the Drainage or Irrigation Structure referenced in O&M manual (Station 243+31). Pipe abandoned under Permit No. 17468 (2004). FS Date: 12/19/2013

Marker with emergency contact information located on waterward slope.

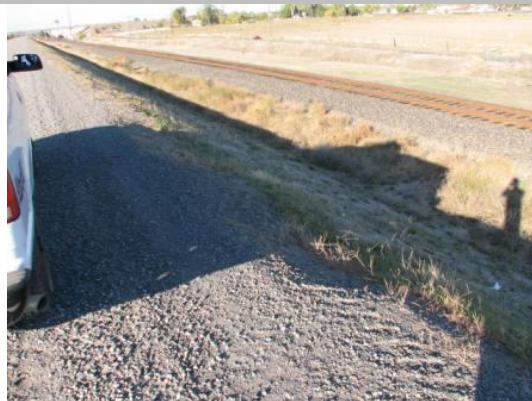
Photo 2 of 2 : FA_2016_NA0001_52_150_20160914_00010.jpg

LM Start	2.33	Rating **	A/W	Issue No.	150 (cont)
LM End	2.33	Issue Type +	Ob	Location *	LS

11/16/2011 Depressions present on levee slope.

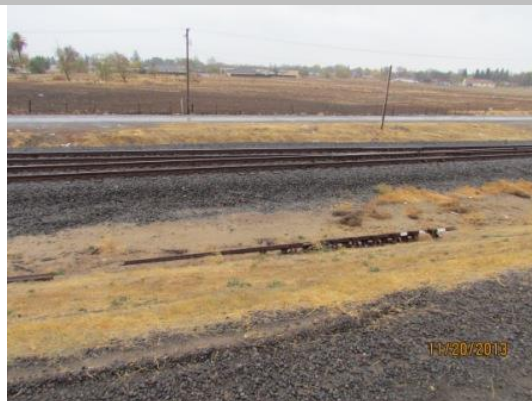
Photo 1 of 1 : FA_2016_NA0001_52_11_20160914_00003.jpg

LM Start	2.52	Rating **	M	Issue No.	11
LM End	2.52	Issue Type +	En	Location *	LS
Category	Earthen Levee			GPS Latitude/Longitude	
				Start	End
Item	Encroachments			38.637177 °	38.637177 °
				-121.471076 °	-121.471076 °
DWR ID	DWR_NA0001_02_f_2013_11				
Comment Code					
MA : Material					
Inspector Comment					
Railroad rails on landside levee slope.

View of the rails at the landside levee toe.

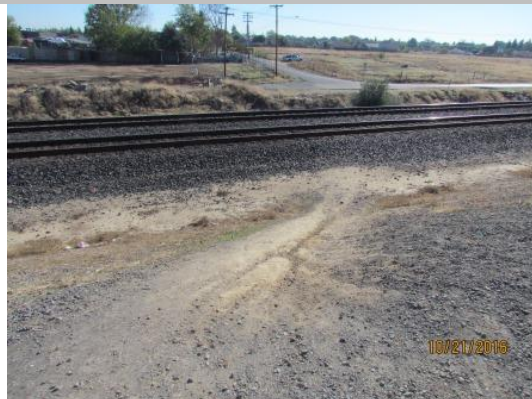
Photo 1 of 1 : FA_2016_NA0001_52_27_20161031_00047.jpg

LM Start	2.59	Rating **	M	Issue No.	27
LM End	2.59	Issue Type +	Ma	Location *	LS
Category	Earthen Levee			GPS Latitude/Longitude	
				Start	End
Item	Slope Stability			38.638109 °	38.638109 °
				-121.471254 °	-121.471254 °
DWR ID	DWR_NA0001_02_f_2016_27				
Comment Code					
S2 : Repair the levee slope damaged by foot traffic and prevent access where possible.					
Inspector Comment

View of the foot path on the landside levee slope.

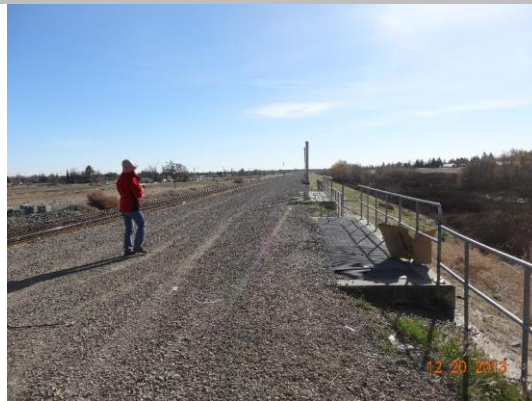
Photo 1 of 2 : UCIP_FA_2016_49862_52893.jpg

Comment Code					
Inspector Comment					
FS_ID:49862 DS_ID:24608 EP_NO: 9596 Repair Type: Non-Urgent Crossing Status: Indicator Found UCIP Comments: Dense vegetation on waterward side limits inspector's inspection. Recommend removing vegetation. FIELD_STRUCT_DESC: [Sump No. 157] 1 of 3: 54-inch steel drainage pipe through the levee, 3 feet below the crown. Steel cutoff wall around pipe under center of levee. Siphon breaker in protective housing located on the waterside (WS) shoulder. Concrete headwall and flap gate located on the WS end. Trench on WS. Pumping plant located on the landside (LS). On March 28, 1995, the Sacramento City Council adopted Resolution No. 95-123 authorizing the execution of Agreement No. 95-065 regarding the transfer of drainage facilities that include Pump Station 7 as described by ARFCD and described by the City of Sacramento as Sump 157. (three 54-inch pipes installed in the siphon breaker structure but only one pipe installed through levee under Permit No. 9596, 9596-A, and 1975 - American River Flood Control District; second pipe installed through levee under Permit No. 9596-B, 1980 - American River Flood Control District; name change completed under Permit 9596-1 (includes work authorized under Permit No. 9596, 9596-A, and 9596-B), 2016 - City of Sacramento) [Additional Reference(s): DWR Levee Log, 2002] FS Date: 12/20/2013

Overview of levee crown.

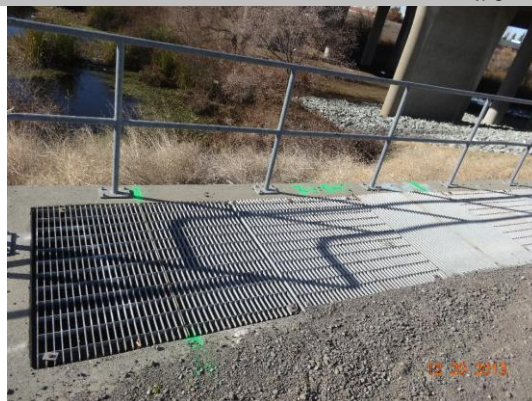
Photo 2 of 2 : UCIP_FA_2016_49862_52891.jpg

FS_ID:49862
DS_ID:24608
EP_NO: 9596
Repair Type: Non-Urgent
Crossing Status: Indicator Found
UCIP Comments: Dense vegetation on waterward side limits inspector's inspection. Recommend removing vegetation.
FIELD_STRUCT_DESC: [Sump No. 157] 1 of 3: 54-inch steel drainage pipe through the levee, 3 feet below the crown. Steel cutoff wall around pipe under center of levee. Siphon breaker in protective housing located on the waterside (WS) shoulder. Concrete headwall and flap gate located on the WS end. Trench on WS. Pumping plant located on the landside (LS). On March 28, 1995, the Sacramento City Council adopted Resolution No. 95-123 authorizing the execution of Agreement No. 95-065 regarding the transfer of drainage facilities that include Pump Station 7 as described by ARFCD and described by the City of Sacramento as Sump 157. (three 54-inch pipes installed in the siphon breaker structure but only one pipe installed through levee under Permit No. 9596, 9596-A, and 1975 - American River Flood Control District; second pipe installed through levee under Permit No. 9596-B, 1980 - American River Flood Control District; name change completed under Permit 9596-1 (includes work authorized under Permit No. 9596, 9596-A, and 9596-B), 2016 - City of Sacramento) [Additional Reference(s): DWR Levee Log, 2002]

Concrete box contains 3-54 inch crossings.

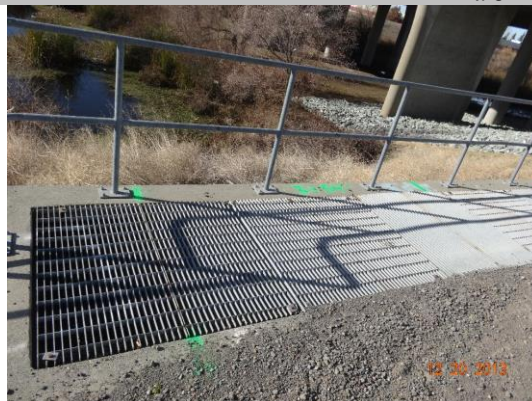
Photo 2 of 2 : UCIP_FA_2016_49863_52901.jpg

Concrete box contains 3-54 inch crossings.

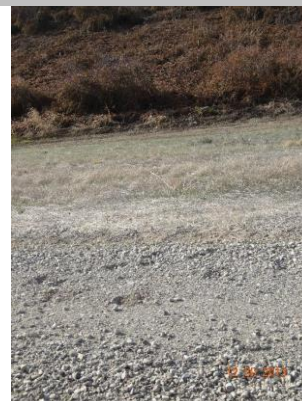
Photo 1 of 2 : UCIP_FA_2016_49938_55459.jpg

FS_ID:49938
DS_ID:24484
EP_NO: N/A
Repair Type: Non-Urgent
Crossing Status: Indicator Found
UCIP Comments: 8/11/2016 Inspected the crossing with Tim Kerr and Richard Marck, LMA representatives, and it appears that this crossing does not go through the levee--unable to confirm. Crossing is believed to have initially started at the LS toe and modified in the 1990s when levee was raised. It is believed that the concrete box frame was added during the levee improvements by the USACE in the 1990s. Crossing was downgraded from Urgent to Non-Urgent due to evidence to indicate that no sink hole is present at this location. Need to confirm if crossing goes through the levee. (DWR UCIP - omagana)12/20/2013 Hole visible just above the concrete box located on landward side--unable to determine if hole is associated with pipe failure or burrow activity. Need to contact owner to determine status and details of crossing's alignment. (DWR UCIP - omagana)

FIELD_STRUCT_DESC: 12-inch corrugated metal (CM) railroad drainage pipe through the levee at unknown depth. (crossing does not appear to go through levee) Crossing appears to be used to drain the landside (LS) berm. Crossing initially started at the LS toe inlet (evidence of inlet is still present 2016). Inlet was moved during the USACE improvement project to raise levee in the 1990s. The inlet is now located at the low point of LS berm where the concrete box is located. [Additional Reference(s): DWR Levee Log, 2002. USACE Sacramento O&M Manual Unit No. 118 Part 2, October 1959, (Station 340+00)].
FS Date: 8/11/2016

View of WS.

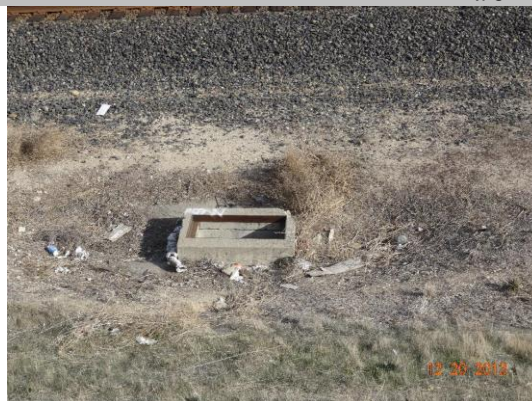
Photo 2 of 2 : UCIP_FA_2016_49938_55458.jpg

FS_ID:49938
DS_ID:24484
EP_NO: N/A
Repair Type: Non-Urgent
Crossing Status: Indicator Found
UCIP Comments: 8/11/2016 Inspected the crossing with Tim Kerr and Richard Marck, LMA representatives, and it appears that this crossing does not go through the levee--unable to confirm. Crossing is believed to have initially started at the LS toe and modified in the 1990s when levee was raised. It is believed that the concrete box frame was added during the levee improvements by the USACE in the 1990s. Crossing was downgraded from Urgent to Non-Urgent due to evidence to indicate that no sink hole is present at this location. Need to confirm if crossing goes through the levee. (DWR UCIP - omagana)12/20/2013 Hole visible just above the concrete box located on landward side--unable to determine if hole is associated with pipe failure or burrow activity. Need to contact owner to determine status and details of crossing's alignment. (DWR UCIP - omagana)

View of concrete box located on LS.

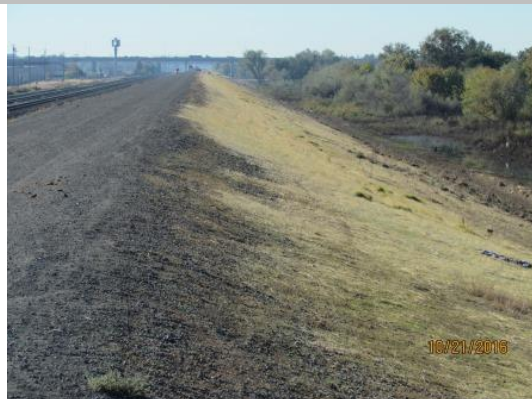
Photo 1 of 1 : FA_2016_NA0001_52_21_20161031_00046.jpg

LM Start	2.88	Rating **	A	Issue No.	21
LM End	3.73	Issue Type +	Ma	Location *	WS
Category	Earthen Levee			GPS Latitude/Longitude	
				Start	End
Item	Vegetation			38.642283 °	38.654472 °
				-121.472065 °	-121.474411 °
DWR ID	DWR_NA0001_02_f_2016_21				
Comment Code					
V1 : Control annual grass and weeds on the levee slopes and easements.					
Inspector Comment					
LMA has exceptional vegetation control program.

View of the vegetation on the waterside levee slope.

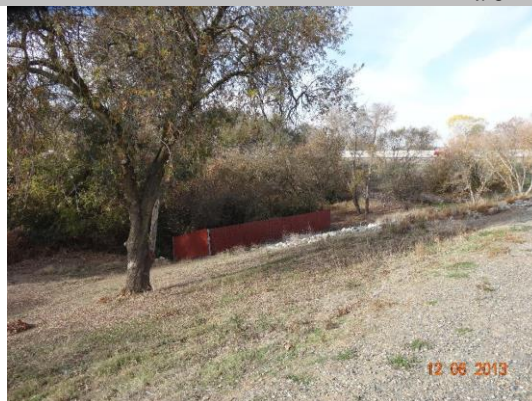
Photo 1 of 2 : UCIP_FA_2016_50047_53005.jpg

Comment Code					
Inspector Comment					
FS_ID:50047 DS_ID:24292 EP_NO: 5776 Repair Type: Non-Urgent Crossing Status: Found UCIP Comments: 8/11/2016 Issue has been addressed--no hole is present at site. Hole could have been associated with burrow activity. Need to contact owner to obtain internal integrity inspection to confirm pipe is in good condition. Crossing has been changed from Urgent to Non-Urgent due to limited evidence to support leak in pipe. (DWR UCIP - omagana)12/3/2013 Hole present next to concrete vault on levee crown (waterward side). Hole could be sink hole or burrow activity unable to determine. Need to contact owner to determine status of crossing and to investigate hole. (DWR UCIP - omagana) FIELD_STRUCT_DESC: [Drainage Plant No. 2] 7 of 8: 18-inch steel drainage pipe through the levee at an unknown depth below the crown. Metal cutoff wall around pipe under landside (LS) shoulder. Siphon breakers in concrete box located on the waterside (WS) shoulder. Pumping plant at LS toe. Access ramp to pumping plant located on LS. Concrete discharge box located on the WS. Flap gate located on the WS end. Outfall structure located on the WS. (Permit No. 5776, 1972 - American River Flood Control District; name change completed under Permit No. 5776-1, 2016 - City of Sacramento) [Additional Reference(s): DWR Levee Log, 2002] FS Date: 8/11/2016

View of WS.

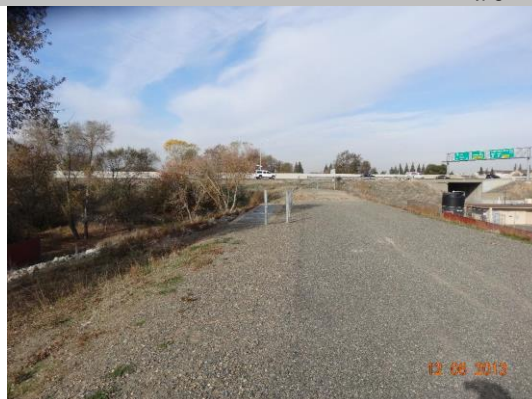
Photo 2 of 2 : UCIP_FA_2016_50047_53004.jpg

Comment Code						
Inspector Comment						
FS_ID:50047 DS_ID:24292 EP_NO: 5776 Repair Type: Non-Urgent Crossing Status: Found UCIP Comments: 8/11/2016 Issue has been addressed--no hole is present at site. Hole could have been associated with burrow activity. Need to contact owner to obtain internal integrity inspection to confirm pipe is in good condition. Crossing has been changed from Urgent to Non-Urgent due to limited evidence to support leak in pipe. (DWR UCIP - omagana)12/3/2013 Hole present next to concrete vault on levee crown (waterward side). Hole could be sink hole or burrow activity unable to determine. Need to contact owner to determine status of crossing and to investigate hole. (DWR UCIP - omagana) FIELD_STRUCT_DESC: [Drainage Plant No. 2] 7 of 8: 18-inch steel drainage pipe through the levee at an unknown depth below the crown. Metal cutoff wall around pipe under landside (LS) shoulder. Siphon breakers in concrete box located on the waterside (WS) shoulder. Pumping plant at LS toe. Access ramp to pumping plant located on LS. Concrete discharge box located on the WS. Flap gate located on the WS end. Outfall structure located on the WS. (Permit No. 5776, 1972 - American River Flood Control District; name change completed under Permit No. 5776-1, 2016 - City of Sacramento) [Additional Reference(s): DWR Levee Log, 2002] FS Date: 8/11/2016

View of levee crown--concrete vault located on WS shoulder.

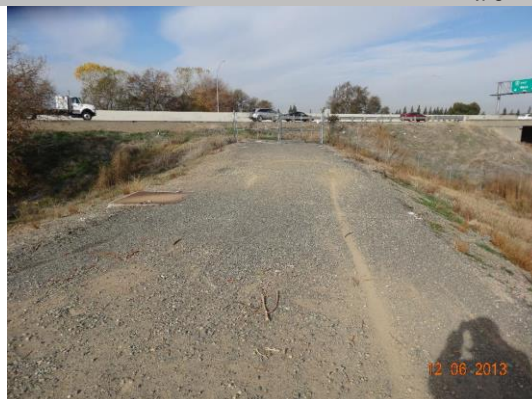
Photo 1 of 2 : UCIP_FA_2016_31224_57130.jpg

LM Start	1.54	Rating **	M	Issue No.	35
LM End	1.54	Issue Type +	En	Location *	WS
Category	Supplemental			GPS Latitude/Longitude	
				Start	End
Item	DWR UCIP Field Study			38.593290 °	38.593290 °
				-121.443980 °	-121.443980 °
DWR ID					
Comment Code					
Inspector Comment					
FS_ID:31224 DS_ID:24644 EP_NO: 2805 Repair Type: Non-Urgent Crossing Status: Indicator Found UCIP Comments: Unable to confirm what crossings are going through levee. Will need to coordinate iwth owner to determine active crossings. FIELD_STRUCT_DESC: [Arden Treatment Plant] 3 of 4: 34-inch concrete encased sewer pipe through the levee, 7.5 feet below the crown. Concrete cutoff wall around pipe under center of levee. Siphon breaker in housing at waterside (WS) shoulder. Treatment plant on landside (LS). FS Date: 12/3/2013

View of levee crown and concrete box located on waterward shoulder.

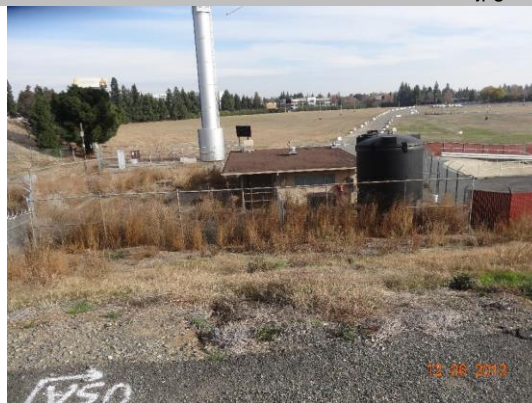
Photo 2 of 2 : UCIP_FA_2016_31225_57134.jpg

LM Start	1.54	Rating **	M	Issue No.	36
LM End	1.54	Issue Type +	En	Location *	WS
Category	Supplemental			GPS Latitude/Longitude	
				Start	End
Item	DWR UCIP Field Study			38.593290 °	38.593290 °
				-121.443980 °	-121.443980 °
DWR ID					
Comment Code					
Inspector Comment					
FS_ID:31225 DS_ID:24645 EP_NO: 2805 Repair Type: Non-Urgent Crossing Status: Indicator Found UCIP Comments: Unable to confirm what crossings are going through levee. Will need to coordinate with owner to determine active crossings. FIELD_STRUCT_DESC: [Arden Treatment Plant] 4 of 4: 34-inch concrete encased sewer pipe through the levee, 6.2 feet below the crown. Concrete cutoff wall around pipe under center of levee. Siphon breaker in housing at waterside (WS) shoulder. Treatment plant on landside (LS). FS Date: 12/3/2013

View of landward side.

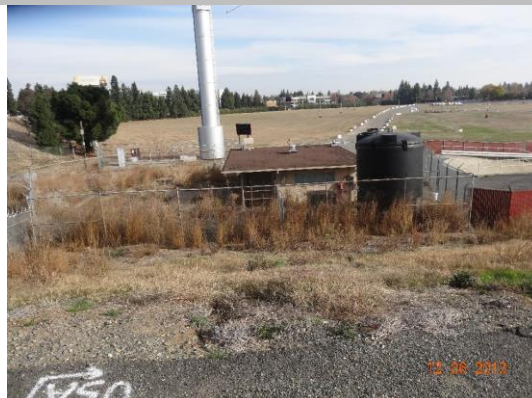
Photo 2 of 2 : UCIP_FA_2016_31227_57138.jpg

Comment Code					
Inspector Comment					
FS_ID:31227					
DS_ID:24293					
EP_NO: 2805					
Repair Type: Non-Urgent					
Crossing Status: Indicator Found					
UCIP Comments: Unable to confirm what crossings are going through levee. Will need to coordinate with owner to determine active crossings.					
FIELD_STRUCT_DESC: [Co Sanitation District No. 2 Pump Station] 18-inch concrete sewer main through the levee, 6 feet below crown.					
Concrete cutoff wall around pipe under center of levee. 2-inch air release valve located on waterside (WS) shoulder. Treatment plant on landside (LS). Crossing continues under the channel and through the opposite levee. (Permit No. 2805-1961)					
FS Date: 12/3/2013

View of landward side.

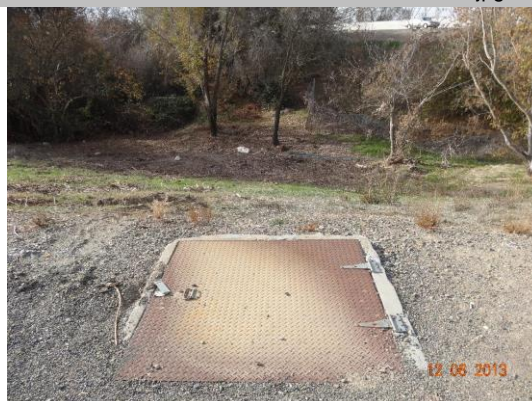
Photo 2 of 2 : UCIP_FA_2016_31223_57123.jpg

FS_ID:31223
DS_ID:24643
EP_NO: 2805
Repair Type: Non-Urgent
Crossing Status: Indicator Found
UCIP Comments: Unable to confirm what crossings are going through levee. Will need to coordinate iwth owner to determine active crossings.
FIELD_STRUCT_DESC: [Co Sanitation District No. 2 Pump Station]: 24-inch reinforced concrete sewer main through the levee, 2.5 feet below the crown. Concrete cutoff wall around pipe under center of levee. Siphon breaker in housing at waterside (WS) shoulder. Treatment plant on landside (LS). (Permit No. 6216-1969) Line connects to an existing 18-inch sewer line and 8-inch line installed under permit no. 6216. The line also connects to an existing 24-inch line located on the LS. The 24-inch line on LS parallels the levee for approximately 54 feet and ends at the pump station.
FS Date: 12/3/2013

Concrete box located on waterward shoulder.

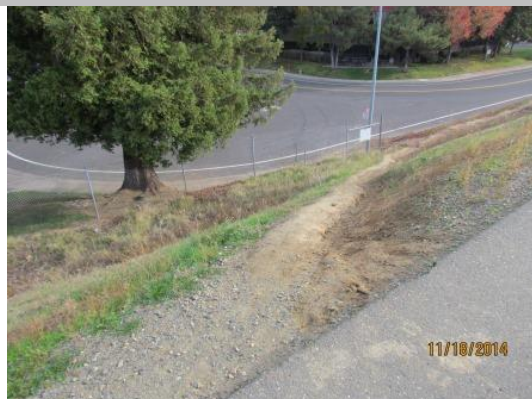
Photo 1 of 1 : FA_2016_NA0001_490_9_20160914_00002.jpg

LM Start	1.82	Rating **	A/W	Issue No.	9
LM End	1.82	Issue Type +	Ma	Location *	LS
Category	Earthen Levee			GPS Latitude/Longitude	
				Start	End
Item	Slope Stability			38.595700°	38.595700°
				-121.448198°	-121.448198°
DWR ID	DWR_NA0001_03_s_2012_9				
Comment Code					
S2 : Repair the levee slope damaged by foot traffic and prevent access where possible.					
Inspector Comment					
Slope repaired. Monitor for possible future erosion.

View of the erosion on landside levee slope due to pedestrian traffic.

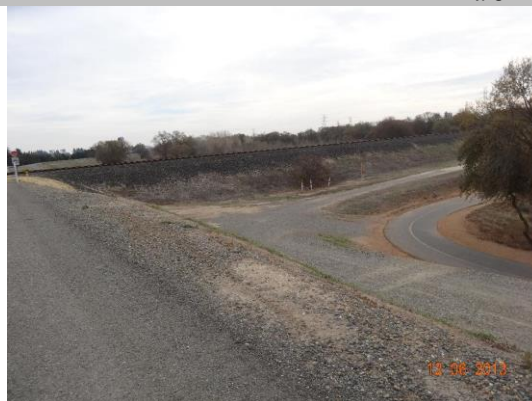
Photo 1 of 2 : UCIP_FA_2016_31230_57146.jpg

LM Start	1.91	Rating **	M	Issue No.	38
LM End	1.91	Issue Type +	En	Location *	LS
Category	Supplemental			GPS Latitude/Longitude	
				Start	End
Item	DWR UCIP Field Study			38.596096 °	38.596096 °
				-121.449815 °	-121.449815 °
DWR ID					
Comment Code					
Inspector Comment					
FS_ID:31230					
DS_ID:24801					
EP_NO: N/A					
Repair Type: Non-Urgent					
Crossing Status: Found					
UCIP Comments: No permit found--need to contact owner to determine status of crossing.					
FIELD_STRUCT_DESC: Gas line through levee at unknown depth.					
Markers visible on waterside (WS) and landside (LS). Kinder Morgan contact's information is 916-363-1666.					
FS Date: 12/6/2013

View of waterward side.

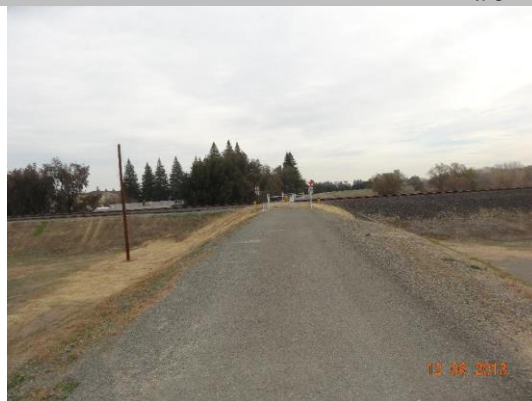
Photo 1 of 2 : UCIP_FA_2016_29826_55135.jpg

LM Start	1.91	Rating **	M	Issue No.	32
LM End	1.91	Issue Type +	En	Location *	LS
Category	Supplemental			GPS Latitude/Longitude	
				Start	End
Item	DWR UCIP Field Study			38.596108 °	38.596108 °
				-121.449887 °	-121.449887 °
DWR ID					
Comment Code					
Inspector Comment					
FS_ID:29826					
DS_ID:24294					
EP_NO: N/A					
Repair Type: Non-Urgent					
Crossing Status: Indicator Found					
UCIP Comments: Unable to confirm the diameter size or which owner is responsible for crossing. Owner could be Quest Communication or MCI--Need to contact owner to confirm crossing and obtain encroachment permit for work.					
FIELD_STRUCT_DESC: Communications conduit through the levee at unknown depth.					
FS Date: 12/6/2013

Overview of levee crown looking upstram at crossing.

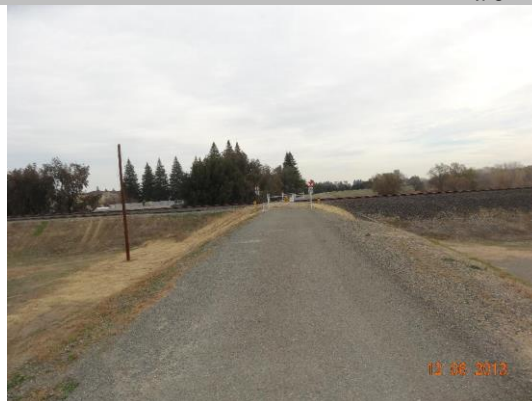
Photo 1 of 2 : UCIP_FA_2016_29827_55141.jpg

LM Start	1.92	Rating **	M	Issue No.	33
LM End	1.92	Issue Type +	En	Location *	LS
Category	Supplemental			GPS Latitude/Longitude	
				Start	End
Item	DWR UCIP Field Study			38.596108 °	38.596108 °
				-121.449887 °	-121.449887 °
DWR ID					
Comment Code					
Inspector Comment					
FS_ID:29827					
DS_ID:24296					
EP_NO: N/A					
Repair Type: Non-Urgent					
Crossing Status: Indicator Found					
UCIP Comments: Unable to confirm the diameter size or which owner is responsible for crossing. Owner could be Quest Communication or MCI--Need to contact owner to confirm crossing and obtain encroachment permit for work.					
FIELD_STRUCT_DESC: 3-inch cable through the levee, 2.5 feet below the crown. Two overhead telephone lines across the levee at location.					
FS Date: 12/6/2013

Overview of levee crown looking upstream at crossing.

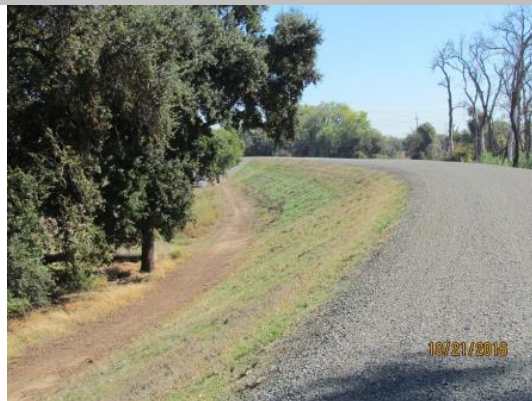
Photo 1 of 1 : FA_2016_NA0001_490_27_20161031_00034.jpg

LM Start	1.94	Rating **	A	Issue No.	27
LM End	2.93	Issue Type +	Ma	Location *	LS
Category	Earthen Levee			GPS Latitude/Longitude	
				Start	End
Item	Vegetation			38.596177 °	38.596375 °
				-121.450456 °	-121.467529 °
DWR ID	DWR_NA0001_03_f_2016_27				
Comment Code					
V1 : Control annual grass and weeds on the levee slopes and easements.					
Inspector Comment					
Acceptable vegetation control.

View of the vegetation on the landside levee slope.

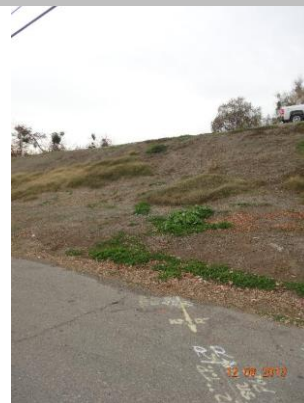
Photo 1 of 2 : UCIP_FA_2016_50049_53391.jpg

Comment Code					
Inspector Comment					
FS_ID:50049 DS_ID:24648 EP_NO: 911 Repair Type: Non-Urgent Crossing Status: Found UCIP Comments: 8/11/2016 Markers found on WS. No markers found on LS. Crossing has been downgraded from Urgent to Non-Urgent, pipe has been marked on WS only. (DWR UCIP - omagana)2/6/2015 Permit information was entered and crossing description updated. (DWR UCIP - omagana)12/3/13 Need to contact owner to determine status of crossing. Markers missing. (DWR UCIP - omagana) FIELD_STRUCT_DESC: 12.75-inch gas line through the levee at unknown depth. Markers found on the waterside (WS) approximately 192 feet and 410 feet from levee crown. No markers found on landside (LS). (line installed under Permit No. 911, 1943 - Pacific Gas and Electric Company [PG&E]) FS Date: 8/11/2016

View of LS slope and USA paint markings indicating alignment.
